**NATIONAL DAM SAFETY PROGRAM. STONY BROOK DAM NUMBER 4**

**STONY BROOK DAM NO. 4**

**NJ 00390**

**PHASE 1 INSPECTION REPORT  
NATIONAL DAM SAFETY PROGRAM**

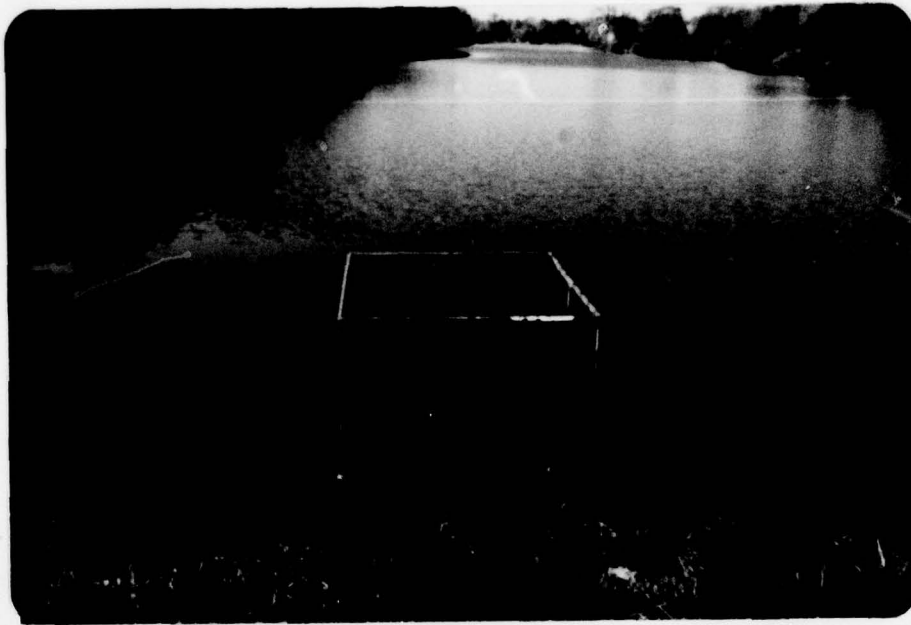
The algae-covered, concrete inlet riser appears to be in satisfactory condition although some light spalling was noted on the outer edges. A long timber has fallen into the riser and is now protruding above the trash bars. The trash rack itself appears to consist of only a single pipe railing around the inlet and is of little use in preventing debris from entering the box

riser. The gate wheel for the low level drain is missing which precludes the possibility of lowering the lake in an emergency situation. The 78-inch diameter discharge conduit and headwall appear in satisfactory condition although there is light erosion around the pipe exit. The rock drain along the downstream toe is no longer uniform in appearance but seems to be functioning as designed since no seepage or moisture was noted beyond the toe.

View of Intake Structure

- Clear the debris which has collected in and around the intake riser;
- Study the feasibility of installing a cover screen on the trash bars;
- Replace and lock the wheel for the gate stem which operates the low level drain;
- Seed or protect with small stone the eroded areas on the upstream berm and area surrounding the outlet structure; and
- Fill the animal burrows.
